# FLATIRONS EVENT CENTER

## ASSESSMENT OF EXISTING BUILDING

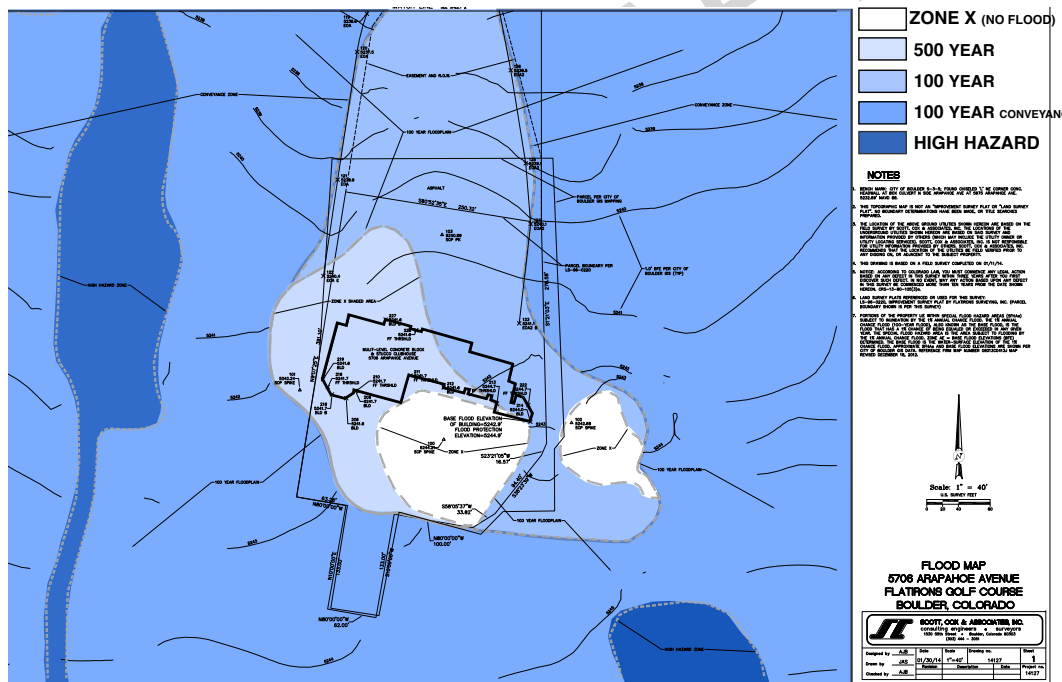
A portion of the existing structure sits within the 100 year flood zone just to the north of the westernmost island and the remainder is within the 500 year flood zone to the northwest of the westernmost island. The building does not sit within the conveyance zone. Please refer to Diagram 1 showing flood zones and the building footprint. For supplementary information refer to the attached survey.

*Flood Diagram 1 showing footprint of building and parking lot on flood map designations*

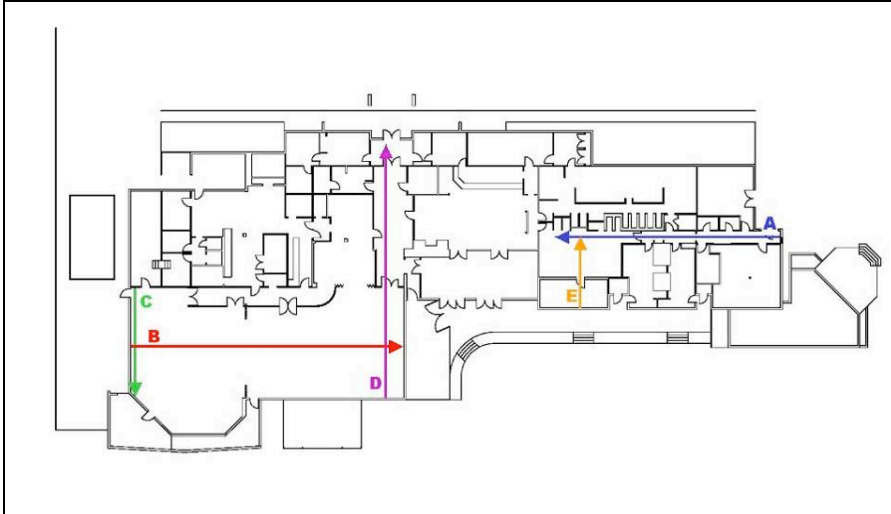
Location (See Figure 2)	Room	Measurement Direction	Distance	Variation from High Point to Low Point	Maximum Slope
A	East Hallway	East to West	80 ft.	0.5"	0.4" in 5 ft.
B	Ballroom	West to East	100 ft.	1.5"	0.5" in 5 ft.
C	West Ballroom	North to South	40 ft.	0.5"	0.4" in 5 ft.
D	Entry Hallway	South to North	90 ft.	0.9"	0.5" in 5 ft.
E	Women's Locker Room	South to North	25 ft.	0.5"	0.5" in 5 ft.

Figure 2. Floor plan of the Event Center Building showing the locations of floor levelness measurements for both 2008 and 2013.

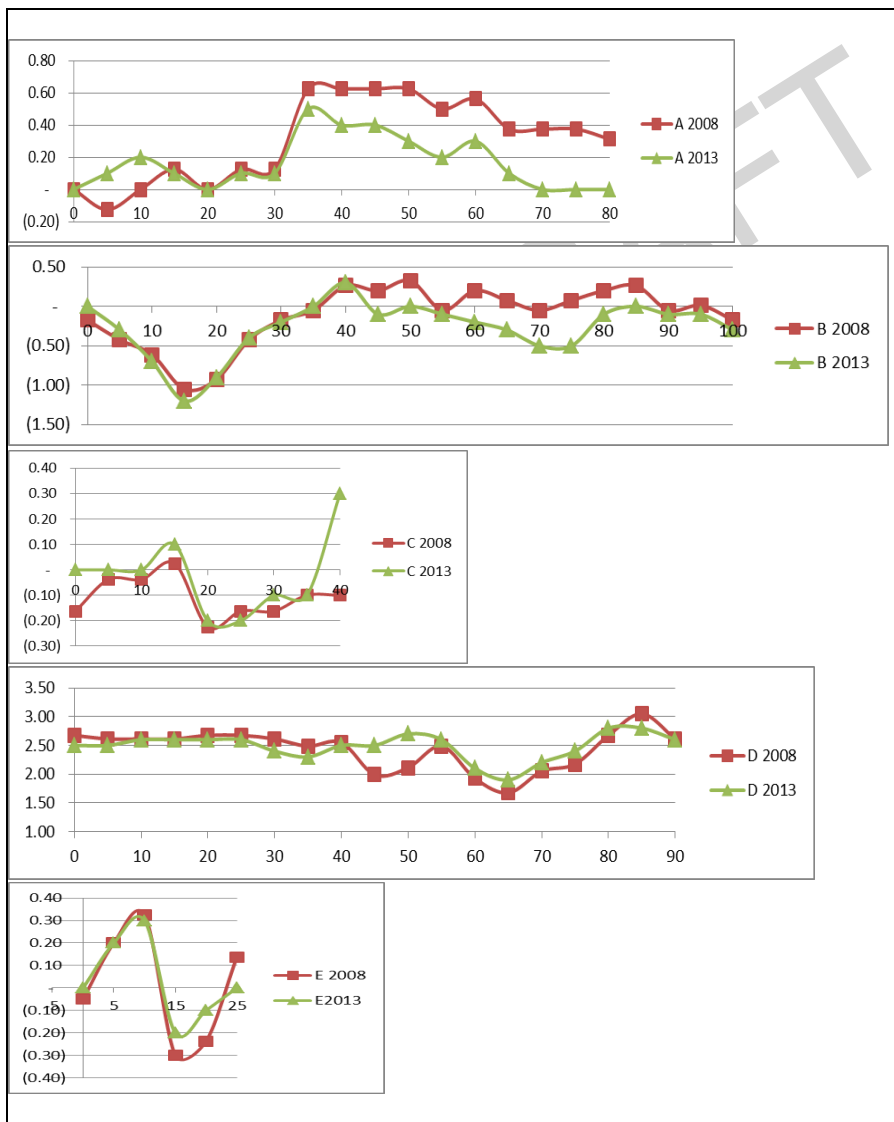
Figure 3. Comparative graphs of relative floor levelness measurements from 2008 and 2013, along paths A, B, C, D, and E. Red lines represent 2008 data and green lines represent 2013 data.

Levelness measurements indicate variations of up to 0.5" in 5 ft and total variations up to 1.5" along a line. These variations are large enough that it is unlikely that they are due to original construction tolerances only. It appears that there has been some post-construction differential vertical movement of the slab.

The comparative graphs shown in Figure 3 generally show fairly minor differences between the elevations measured in 2008 and those measured in 2013. However, there is one notable exception. The measurement at the southwest corner of the building is about 0.4" higher in 2013 than measured in 2008. There is also some significant cracking in the exterior finishes and distress at interior finishes in this area that were not observed in 2008, as shown in Figure 4 through Figure 7.

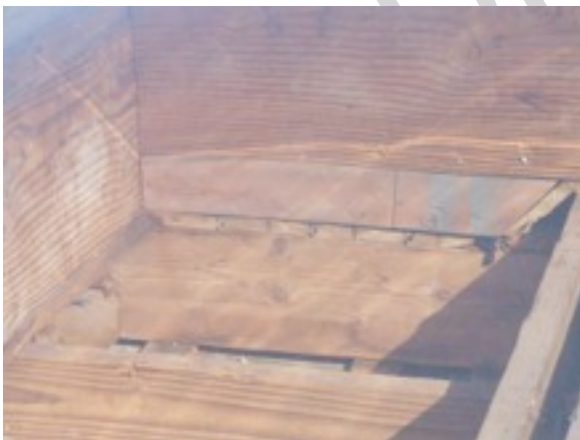
There appear to be at least three different roof structural systems within the building. At the center of the building (near the stone fireplace) it appears that the roof structure includes 2×8 nominal dimensional lumber roof joists with 1×6 nominal tongue-and-groove wood plank decking (Figure 8). This is likely the original building roof construction. At the east end of the building including the locker rooms, ANA observed 2×6 and 2×12 dimensional lumber roof joists at 16 inches on-center with approximately  $\frac{3}{4}$  inch-thick plywood roof decking (Figure 9). These areas also generally had approximately  $\frac{1}{2}$  inch-thick plywood ceiling sheathing beneath the roof joists and cement board ceiling finish. At the west end of the building, the roof framing in the office addition was observed. This framing consists of 8 inch-deep steel studs at 24 inches on-center with approximately  $\frac{5}{8}$  inch-thick plywood decking (Figure 10).

*Figure 8. View looking through the skylight of roof framing near the stone chimney showing tongue-and-groove planking and dimensional lumber framing.*

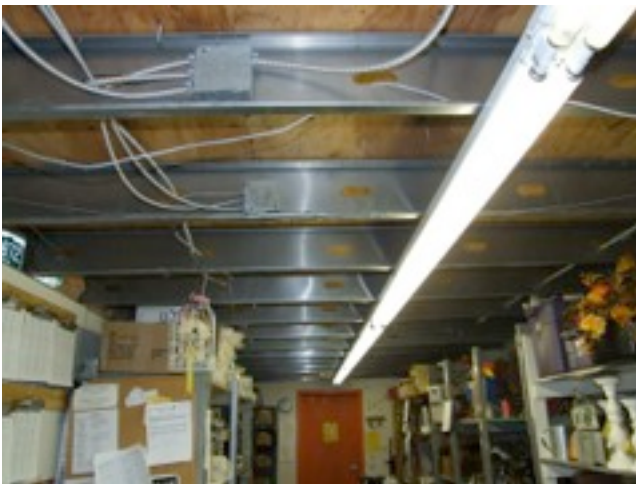
Figure 10. View of metal stud roof framing at the office addition on the west end of the building.

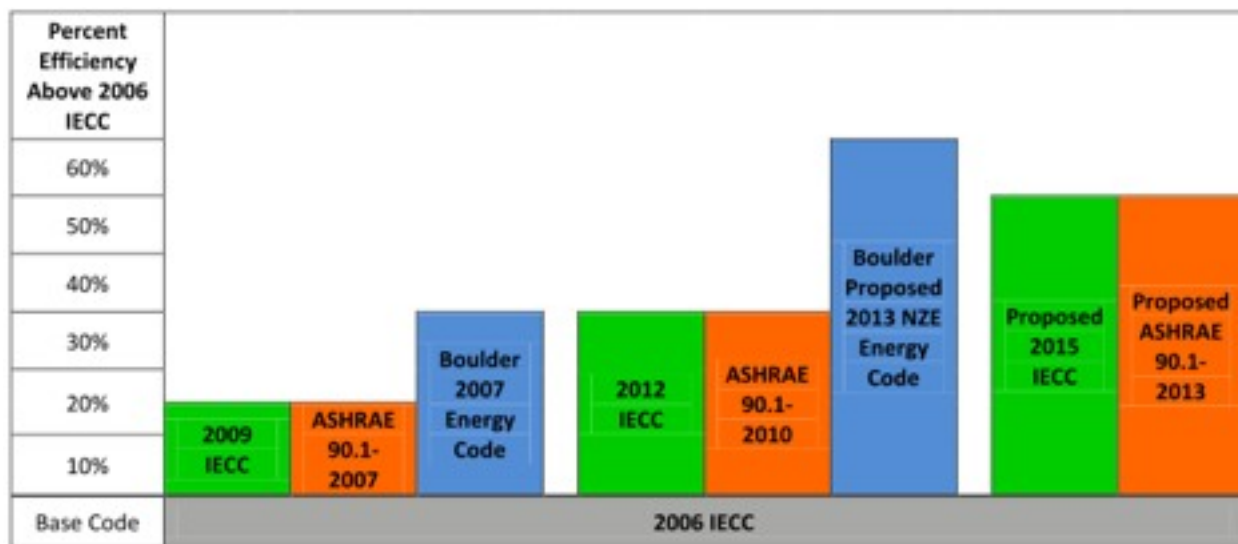
Figure 1.

As of January 31st, 2014, new code requirements (the City Of Boulder Proposed 2013 NZE Energy Code) will take effect in the City of Boulder, requiring commercial buildings to exceed the IECC 2012 requirements by 30% (Figure 1). The City of Boulder Planning Department has not yet provided guidance on specific methods to meet the new, considerably stricter code.
